**SURVEY & REMONUMENTATION**

Ottawa County Remonumentation  
**LAND CORNER RECORDATION CERTIFICATE**  
 Filing Requirement of Act 74, Mich. P.A. 1970

<u>Ottawa</u> (County)	Located In:	Corner Code =#
1. Public Land Survey	T <u>5N</u> R <u>15W</u>	<u>A-4 (W<math>\frac{1}{2}</math>, 7)</u>
	T _____ R _____	<u>Holland Twp.</u>
	T _____ R _____	_____
	T _____ R _____	_____
2. Property Controlling in Section	S _____ T _____ R _____	_____
	S _____ T _____ R _____	_____
3. Miscellaneous Property in Sec.	S _____ T _____ R _____	_____
	S _____ T _____ R _____	_____
4. Lot No. _____, Recorded Plat _____		
5. Private Claims _____

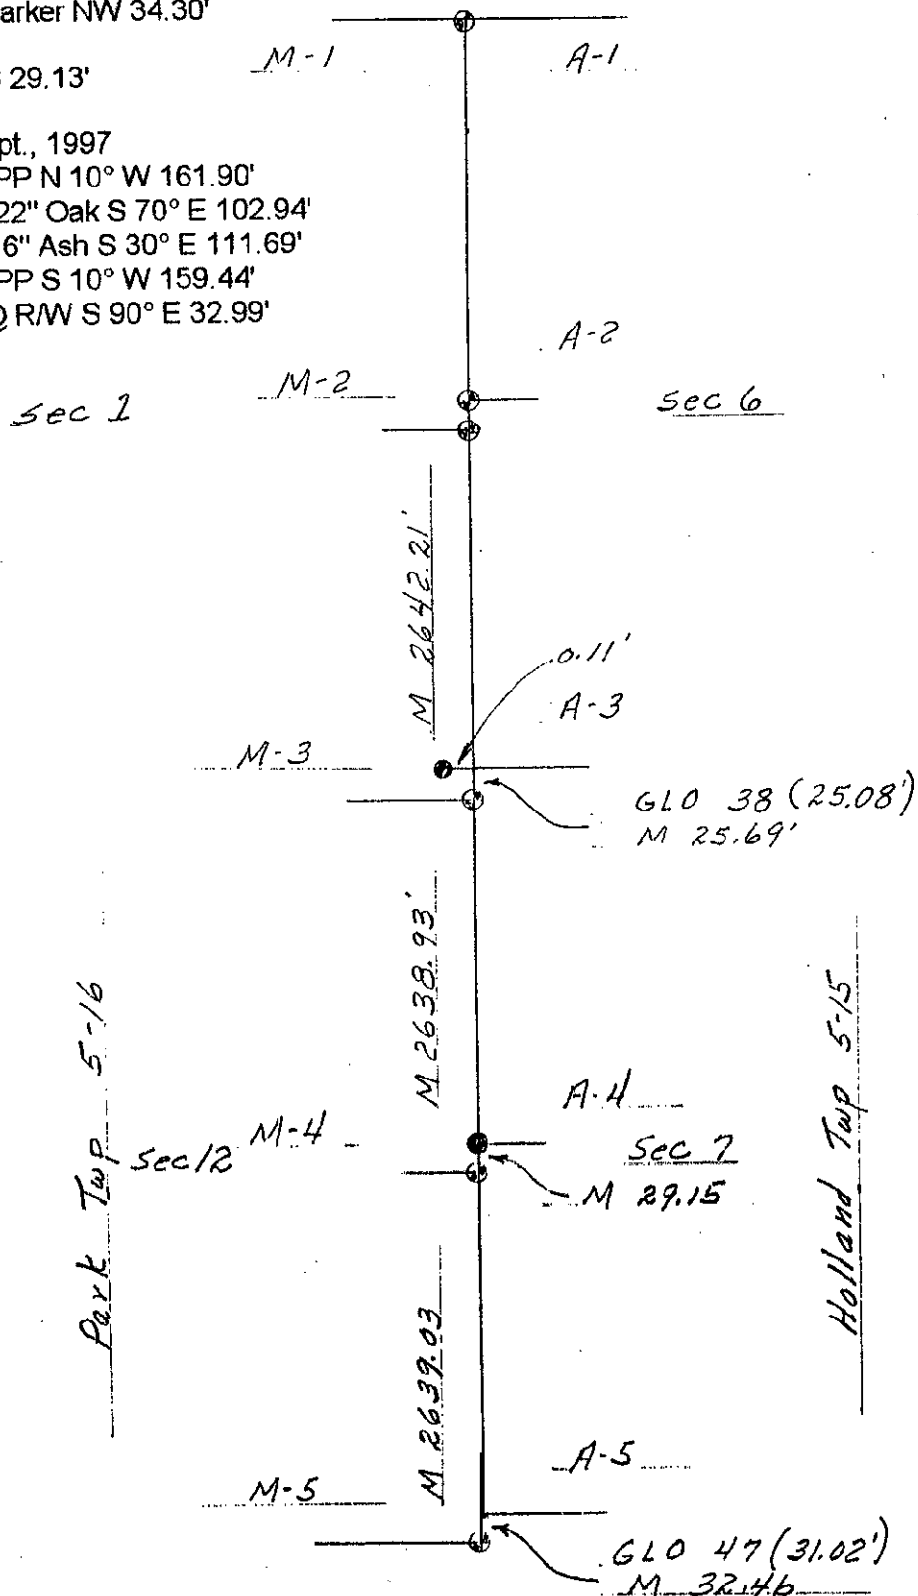
A-4

LCRC 5-15, March, 1983  
 NW 33.90' Wolverine Pipeline Marker  
 S 29.13' Park Twp. "T" iron  
 SE 37.62' to C/L Wolverine Pipeline Marker  
 ESE 103.93' Nail & Cap S side 20" Oak  
 E 33.0' to RLS iron

Exxel, June, 1984  
 4" CI Mon.  
 Nail in side 16" Oak ESE 102.72'  
 Nail in side PP NNW 161.64'  
 C/L pipeline marker NW 34.30'  
 Iron E 33.08'  
 E ¼ Sec. 12 S 29.13'

Nederveld, Sept., 1997  
 Nail in E side PP N 10° W 161.90'  
 Nail in N side 22" Oak S 70° E 102.94'  
 Nail in W side 6" Ash S 30° E 111.69'  
 Nail in E side PP S 10° W 159.44'  
 N/A capped @ R/W S 90° E 32.99'
