SURVEY & REMONUMENTATION

**OTTAWA COUNTY REMONUMENTATION
LAND CORNER RECORDATION CERTIFICATE
Filing Requirement of Act 74, Mich. P.A. 1970**

Ottawa (County)	Located In:	Corner Code #
1. Public Land Survey	T 5N R 16W	F-5 N1/4 Cor
	T R	Sec 16
	T R	Park Twp.
2. Property Controlling in Section	S T R	
	S T R	
3. Miscellaneous Property in Sec.	S T R	
	S T R

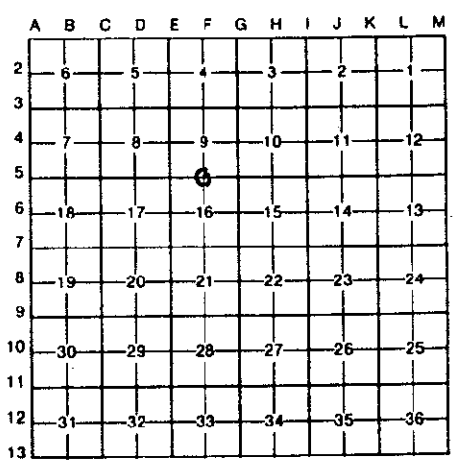
F-5 Govt Land Office Survey Notes 1832-Surveyor, Calvin Britain Set 1/2 mile post 10" Beech N41°E 27 links 12" Beech S36°W 10 links	F-5 Recorded in Liber 1, Page 111 Oct. 7, 1971 Fd 2" round iron 10" Tw Beech S70°E 77.76' 30" Beech SW 65.56' 15" Red Pine NE 86.66' NE Cor Conc Pillar SW 46.05' SW Cor Bldg, NW 82.74'	F-5 Recorded in Liber 3 Page 313, Nov. 30, 1978 Fd 1 3/4" rd steel plug in conc. road 14" Maple S72°E 59.35' NW Cor Conc Pillar S43°E 46.80' NE Cor Conc Pillar S46°W 46.10' SE Cor siding of store bldg N36°W 64.28'
---	--	--

F-5 Found 3/4" steel pin in concrete over concrete monument in monument box and accepted it as a careful and faithful perpetuation of the position of the original corner	NE Corner Pillar AZ 225° 46.05'	 PEER APPROVED 12/12/94
SE Corner Siding at Store Building	AZ 323° 64.25'	
Found Scar in N Side 26" Maple	AZ 108° 59.40'

F-5 Set O.C. Remon Iron and Cap in Monument Box		
O.C. Remon Tag & Nail in side 12" Twin Maple	AZ. 30°	78.40'
O.C. Remon Tag & Nail in side 26" Maple	AZ. 108°	59.60'
O.C. Remon Tag & Nail in side 38" Beech	AZ. 214°	67.94'
SW Cor Concrete Foundation of Porch	AZ. 305°	78.93'
