**SURVEY &
REMONUMENTATION**

OTTAWA COUNTY REMONUMENTATION
LAND CORNER RECORDATION CERTIFICATE
Filing Requirement of Act 74, Mich. P.A. 1970

(County)	Located In:	Corner Code #
1. Public Land Survey	T <u>8N</u> R <u>16W</u>	D-3, S $\frac{1}{2}$ Corner
	T _____ R _____	Section 5
	T _____ R _____	Spring Lake Twp.
	T _____ R _____	
2. Property Controlling in Section	S _____ T _____ R _____	
	S _____ T _____ R _____	
3. Miscellaneous Property in Sec.	S _____ T _____ R _____	
	S _____ T _____ R _____

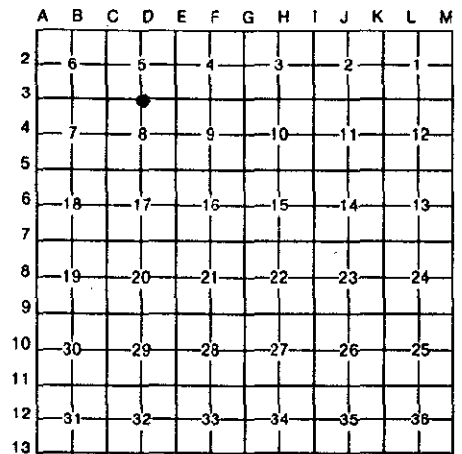
A. Description of original monument and accessories and/or subsequent restoration:

04-03-1837	Liber 5, Pg. 53, 05-17-83	Liber 1, Pg. 235, 01-11-72
Post set by John Mullet, D.S.	Set Cast Iron Monument	Found Iron Pipe, Raised w/ ang. iron
South 70 10" Tamarack	SE 53.54 Power Pole	S45°E 53.11 Nail in face Power Pole
	WSW 26.28 Light Pole	SE 60.40 Nail in face 9" Ced. Post
	NE 49.57 ϵ Hydrant	S70°W 26.29 Light Pole
	NW 49.45 Steel Gate Post

B. Description of corner evidence found and/or method applied in restoring or reestablishing corner:

Found broken off Cast Iron Monument in Monument Box and accepted as a careful and faithful perpetuation of the position of the original corner.

Liber 5, Pg. 53, 05-17-83	Liber 1, Pg. 235, 01-11-72
WSW 26.28 Light Pole	S 45° E 53.11 Nail in Face of Power Pole
NE 49.57 ϵ Hydrant	S 70° W 26.29 Light Pole
SE 53.54 ϵ Power Pole
