LAND CORNER RECORDATION CERTIFICATE
 Filing Requirement of Act 74, Mich. P.A. 1970

SURVEY & REMONUMENTATION

Section Corner common to Sections 19, 20, 29 & 30, T49N R42W.

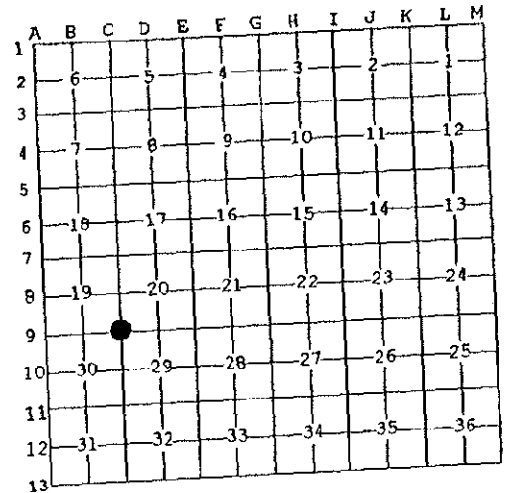
At the corner position I set a 2 $\frac{1}{2}$ "x30" split base aluminum pipe with a 3" cap stamped to read: County Remonumentation, T49N R42W, S19, S20, S29, S30, 1999, P.S. 17610. I established three bearing trees and a reference object.

Nail in 9" H. Maple	N62°W	55.12'	-	Nail in 10" H. Maple	S80°E	78.38'
Nail in 9" H. Maple	N05°W	67.85'	-	6' Steel Sign Post	South	0.43'

No original evidence was found. There was a 4"x4" tag on a 20" Maple dated 1951 marked approximate corner 10 Links North. The Bessemer Forest Service confirmed this information. The SW $\frac{1}{4}$ of SW $\frac{1}{4}$, Section 20, has been farmed since the 1930'S. The fence posts are still standing and the fields are being mowed. In 1946 a major logging road to service White River Lumber Co. in Bergland was built and crossed through the Southwest Corner of Section 20. This would have destroyed the Y. Birch bearing tree. I accepted the intersection of the projection of the South & West fence lines as being the most logical position for the Corner.
