LAND CORNER RECORDATION CERTIFICATE
 Filing Requirement of Act 74, Mich. P.A. 1970

(K-3) Corner of Sections 1, 2, 11, & 12, T50N, R38W

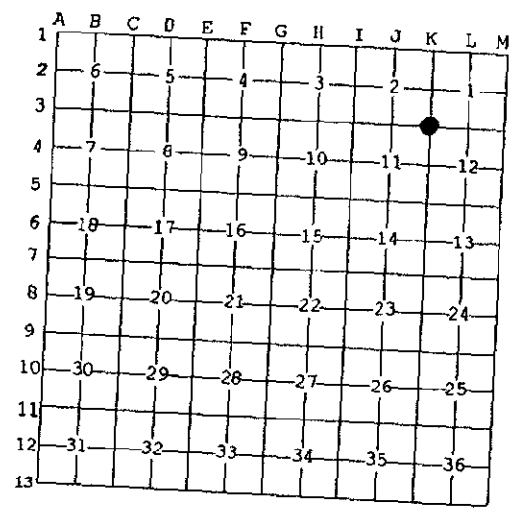
C. Description of monument for corner and accessories established to perpetuate locating the position of the corner:
 Corner is a 5/8" iron pin with a 3" diameter aluminum cap stamped to read: COUNTY REMONUMENTATION; T.50N, R.38W; S. 1, S. 2, S. 11, S. 12; 1997; P.S. 37273. I also established a reference monument (R.M.) to the West, a 2" x 30" aluminum pipe with a 3" diameter aluminum cap stamped to indicate that the corner is East 24.43'.

8" Twin Soft Maple	N 57° W	104.06'
4" White Birch	S 16° E	91.99'
Power Pole	S 10° W	200.32'
R.M.	N 89° 43' 41" W	24.43'
E 1/4 Cor. Sec. 11	S 00° 19' 30" E	2648.06' (meas.)
