LAND CORNER RECORDATION CERTIFICATE
Filing Requirement of Act 74, Mich. P.A. 1970

A. Description of original monument and accessories and/or subsequent restoration:
(G-2) 1/4 Corner of Sections 3 & 4, T51N, R40W

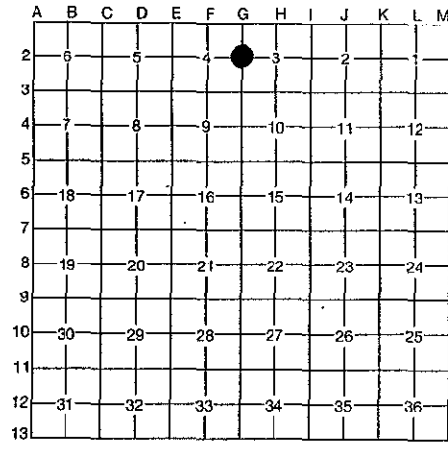
C. Description of monument for corner and accessories established to perpetuate locating the position of the corner:
 Corner is a 1/2" iron encased in a 6" diameter concrete monument with a 2" diameter aluminum cap stamped to read: 1/4 S. 3, S. 4; T51N, R.40W; 1996; P.S. 37273.

- Witnesses:**
- 12" Twin Soft Maple N 88° E 9.00' (existing blaze)
 - 7" Soft Maple S 55° E 19.45'
 - 7" Maple S 14° E 18.30'
 - 5" Soft Maple N 56° W 11.11'
 - Steel Sign Post North 0.94'
