LAND CORNER RECORDATION CERTIFICATE
Filing Requirement of Act 74, Mich. P.A. 1970

(J9) Quarter corner common to Sections 23 & 26. 1850: Established by A.Merryweather on line between Section corners 40.065 chains east and west. Set post. Balsam 6 N30E 3 links, Balsam 5 S20W 11 links.
 (7-Sec. 27) North 1/16 corner between Sections 26 & 27. Not established in the original survey.

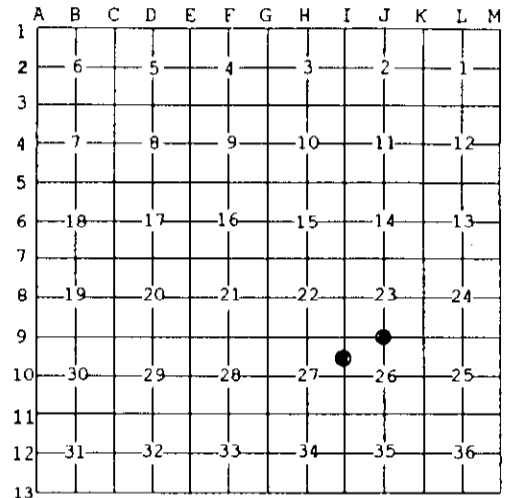
(J9) The original post and accessories were not recovered. Found no acceptable evidence of the position of the original corner on the ground. Reestablished the corner midway and on a line of mean true bearing between Section corners 2661.89 ft. east and west. From the corner thus established, found a post marking approximate corner, by USFS, N35E 39.4' distant.
 (7-Sec. 27) Established the corner midway and on a straight line between Section and Quarter corners 1315.90' north and south.

(J9) Set 1"IDx36" I.pipe with 4" alum. MDNR cap. Blazed, scribed, and set measuring nails in: 14" Cedar S38W 21.75' "1/4S NBT" 8" Cedar S12W 18.35' do 10" Cedar S89W 29.35' do 7" Cedar N53E 25.1' do Set Cedar post adjacent. Bearings are magnetic. Distances are to nail with tag.	(7) Set 1"IDx36" I.pipe with 4" alum. MDNR cap. Blazed, scribed, and set measuring nails in: 8" Maple N04W 3.6' "N1/16 BT" 8" twin Maple S75W 13.25' do 6" Maple S22E 9.5' do 5" Maple East 17.6' do Set Cedar post adjacent. Bearings are magnetic. Distances are to nail with tag.
---	---
