**1996 REMONUMENTATION PROGRAM
LAND CORNER RECORDATION CERTIFICATE
Filing Requirement of Act 74, Mich. P.A. 1970**

For corners in Fremont Twp.

<u>Tuscola</u> (County)	Located In:	Corner Code #
1. Public Land Survey	T <u>11</u> N R <u>9E</u>	<u>M-2</u> ✓
	T <u> </u> R <u> </u>	<u> </u>
	T <u>11</u> N R <u>10E</u>	<u>A-2</u>
	T <u> </u> R <u> </u>	<u> </u>
2. Property Controlling in Section	S <u> </u> T <u> </u> R <u> </u>	<u> </u>
	S <u> </u> T <u> </u> R <u> </u>	<u> </u>
3. Miscellaneous Property in Sec.	S <u> </u> T <u> </u> R <u> </u>	<u> </u>
	S <u> </u> T <u> </u> R <u> </u>	<u> </u>

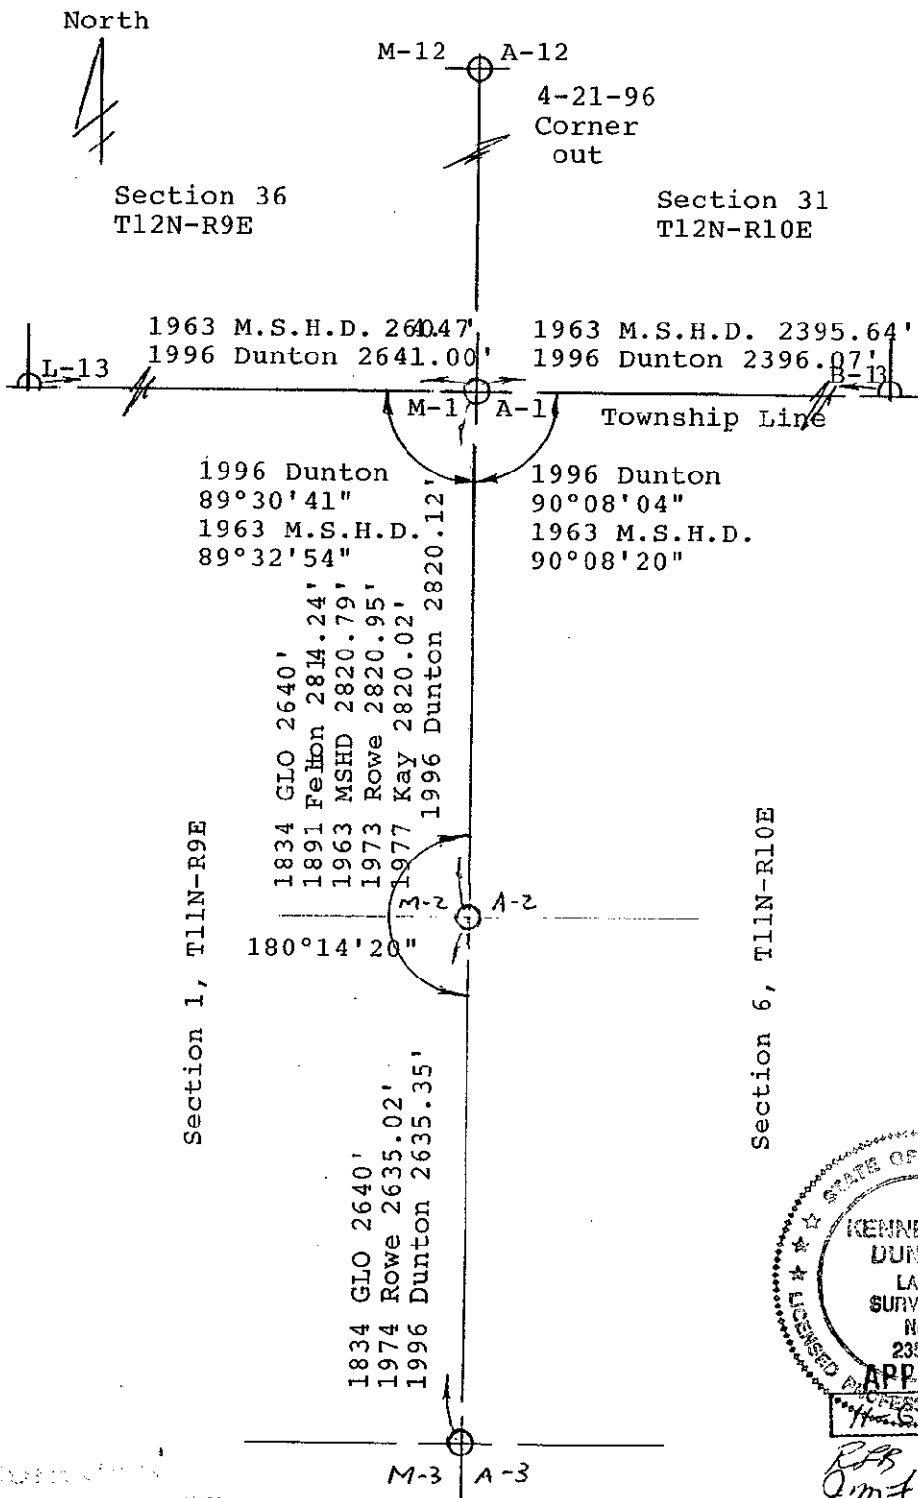
M-2 (Page 2 of 3)

Feb. 27, 1985

Survey by David T. Rowe, Land Surveyor #11192, Liber 550-Page 1024

Fnd. 3/8" octog. rod.

N70°W 110.05' fnd. nail & cap in P.P.

S50°W 52.80' fnd. nail w/flag in 4" Elm.

S40°E 53.61' fnd. NHL w/flag on MBT guard post.
