**1996 REMONUMENTATION PROGRAM
LAND CORNER RECORDATION CERTIFICATE
Filing Requirement of Act 74, Mich. P.A. 1970**

For corners in Dayton Twp.

<u>Tuscola</u> (County)	Located In:	Corner Code #
1. Public Land Survey	T <u>11N</u> R <u>10E</u>	<u>M-9</u>
	T <u>11N</u> R <u>11E</u>	<u>A-9</u>
2. Property Controlling in Section	S <u> </u> T <u> </u> R <u> </u>	<u> </u>
3. Miscellaneous Property in Sec.	S <u> </u> T <u> </u> R <u> </u>	<u> </u>

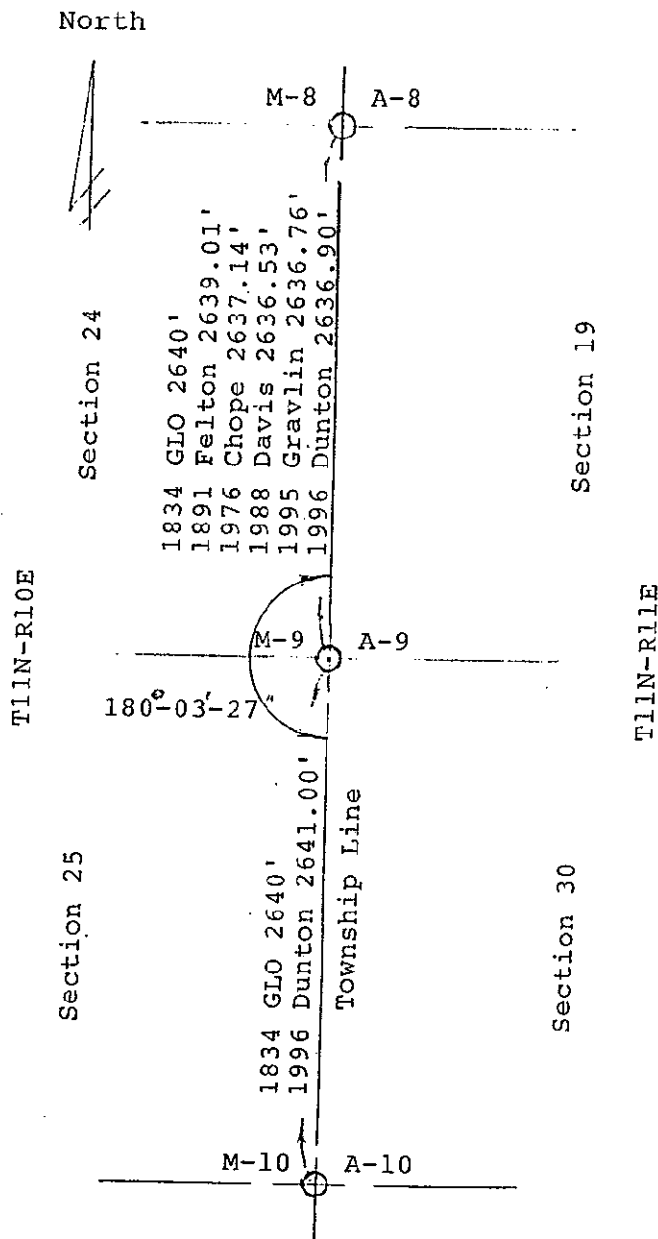
April 17, 1995

Survey by Earl E. Gravlin, Land Surveyor #23510, Liber 681-Pages 1408 & 1409.

Fnd. 1/2" re-rod.

N45°E 42.30' 36" CMP.

S20°E 36.0' stop sign.

N35°W 39.48' stop sign.

Found 1/2" rod in monument box. Held as the best evidence of the original corner.
