1996 REMONUMENTATION PROGRAM
 LAND CORNER RECORDATION CERTIFICATE
 Filing Requirement of Act 74, Mich. P.A. 1970

For corners in S. Akron Twp.

<u>Tuscola</u> (County)	Located In:	Corner Code #
1. Public Land Survey	<u>T14NR 8E</u>	<u>B-13</u>
	T <u> </u> R <u> </u>	<u> </u>
	T <u> </u> R <u> </u>	<u> </u>
	T <u> </u> R <u> </u>	<u> </u>
2. Property Controlling in Section	S <u> </u> T <u> </u> R <u> </u>	<u> </u>
	S <u> </u> T <u> </u> R <u> </u>	<u> </u>
3. Miscellaneous Property in Sec.	S <u> </u> T <u> </u> R <u> </u>	<u> </u>
	S <u> </u> T <u> </u> R <u> </u>	<u> </u>

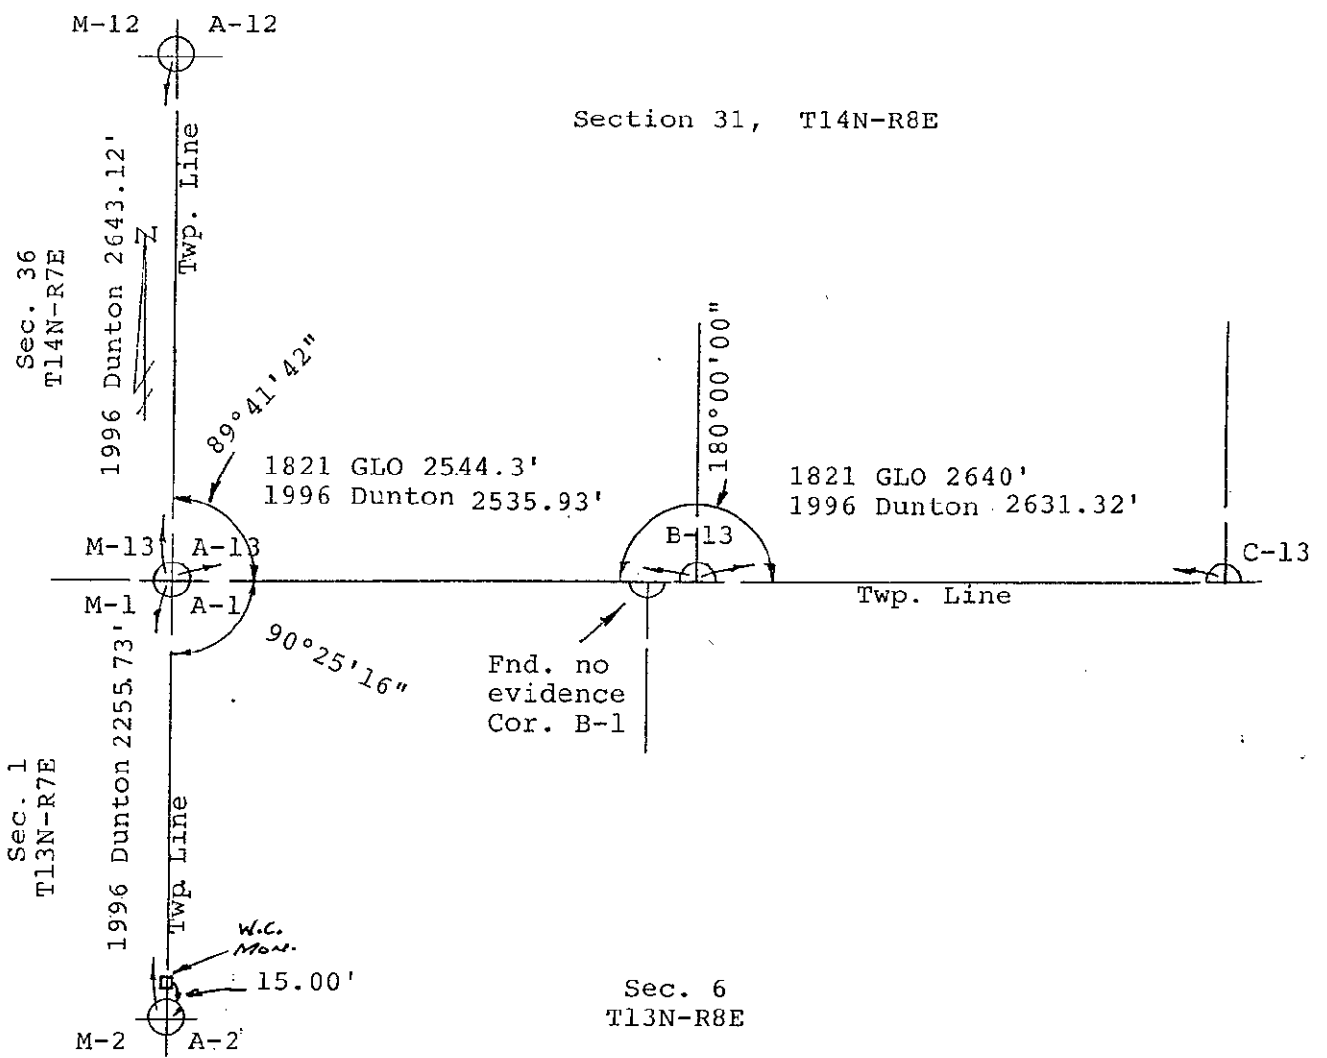
Section 31, T14N-R8E

No evidence of corner B-13 found. Set proportional to G.L.O. measure and on line between Corners A-13 and C-13, T14N-R8E. Accepted this position as the proper location of Corner B-13.
 Note: Corner falls in line with division of fields North.
