MICHIGAN DEPARTMENT OF CONSERVATION
CROOKED LAKE

AREA 110 ACRES

VAN BUREN COUNTY T. 4 S., R. 16 W., SEC. 32
 SURVEY AND SOUNDINGS SEPT. 10-SEPT. 14, 1965

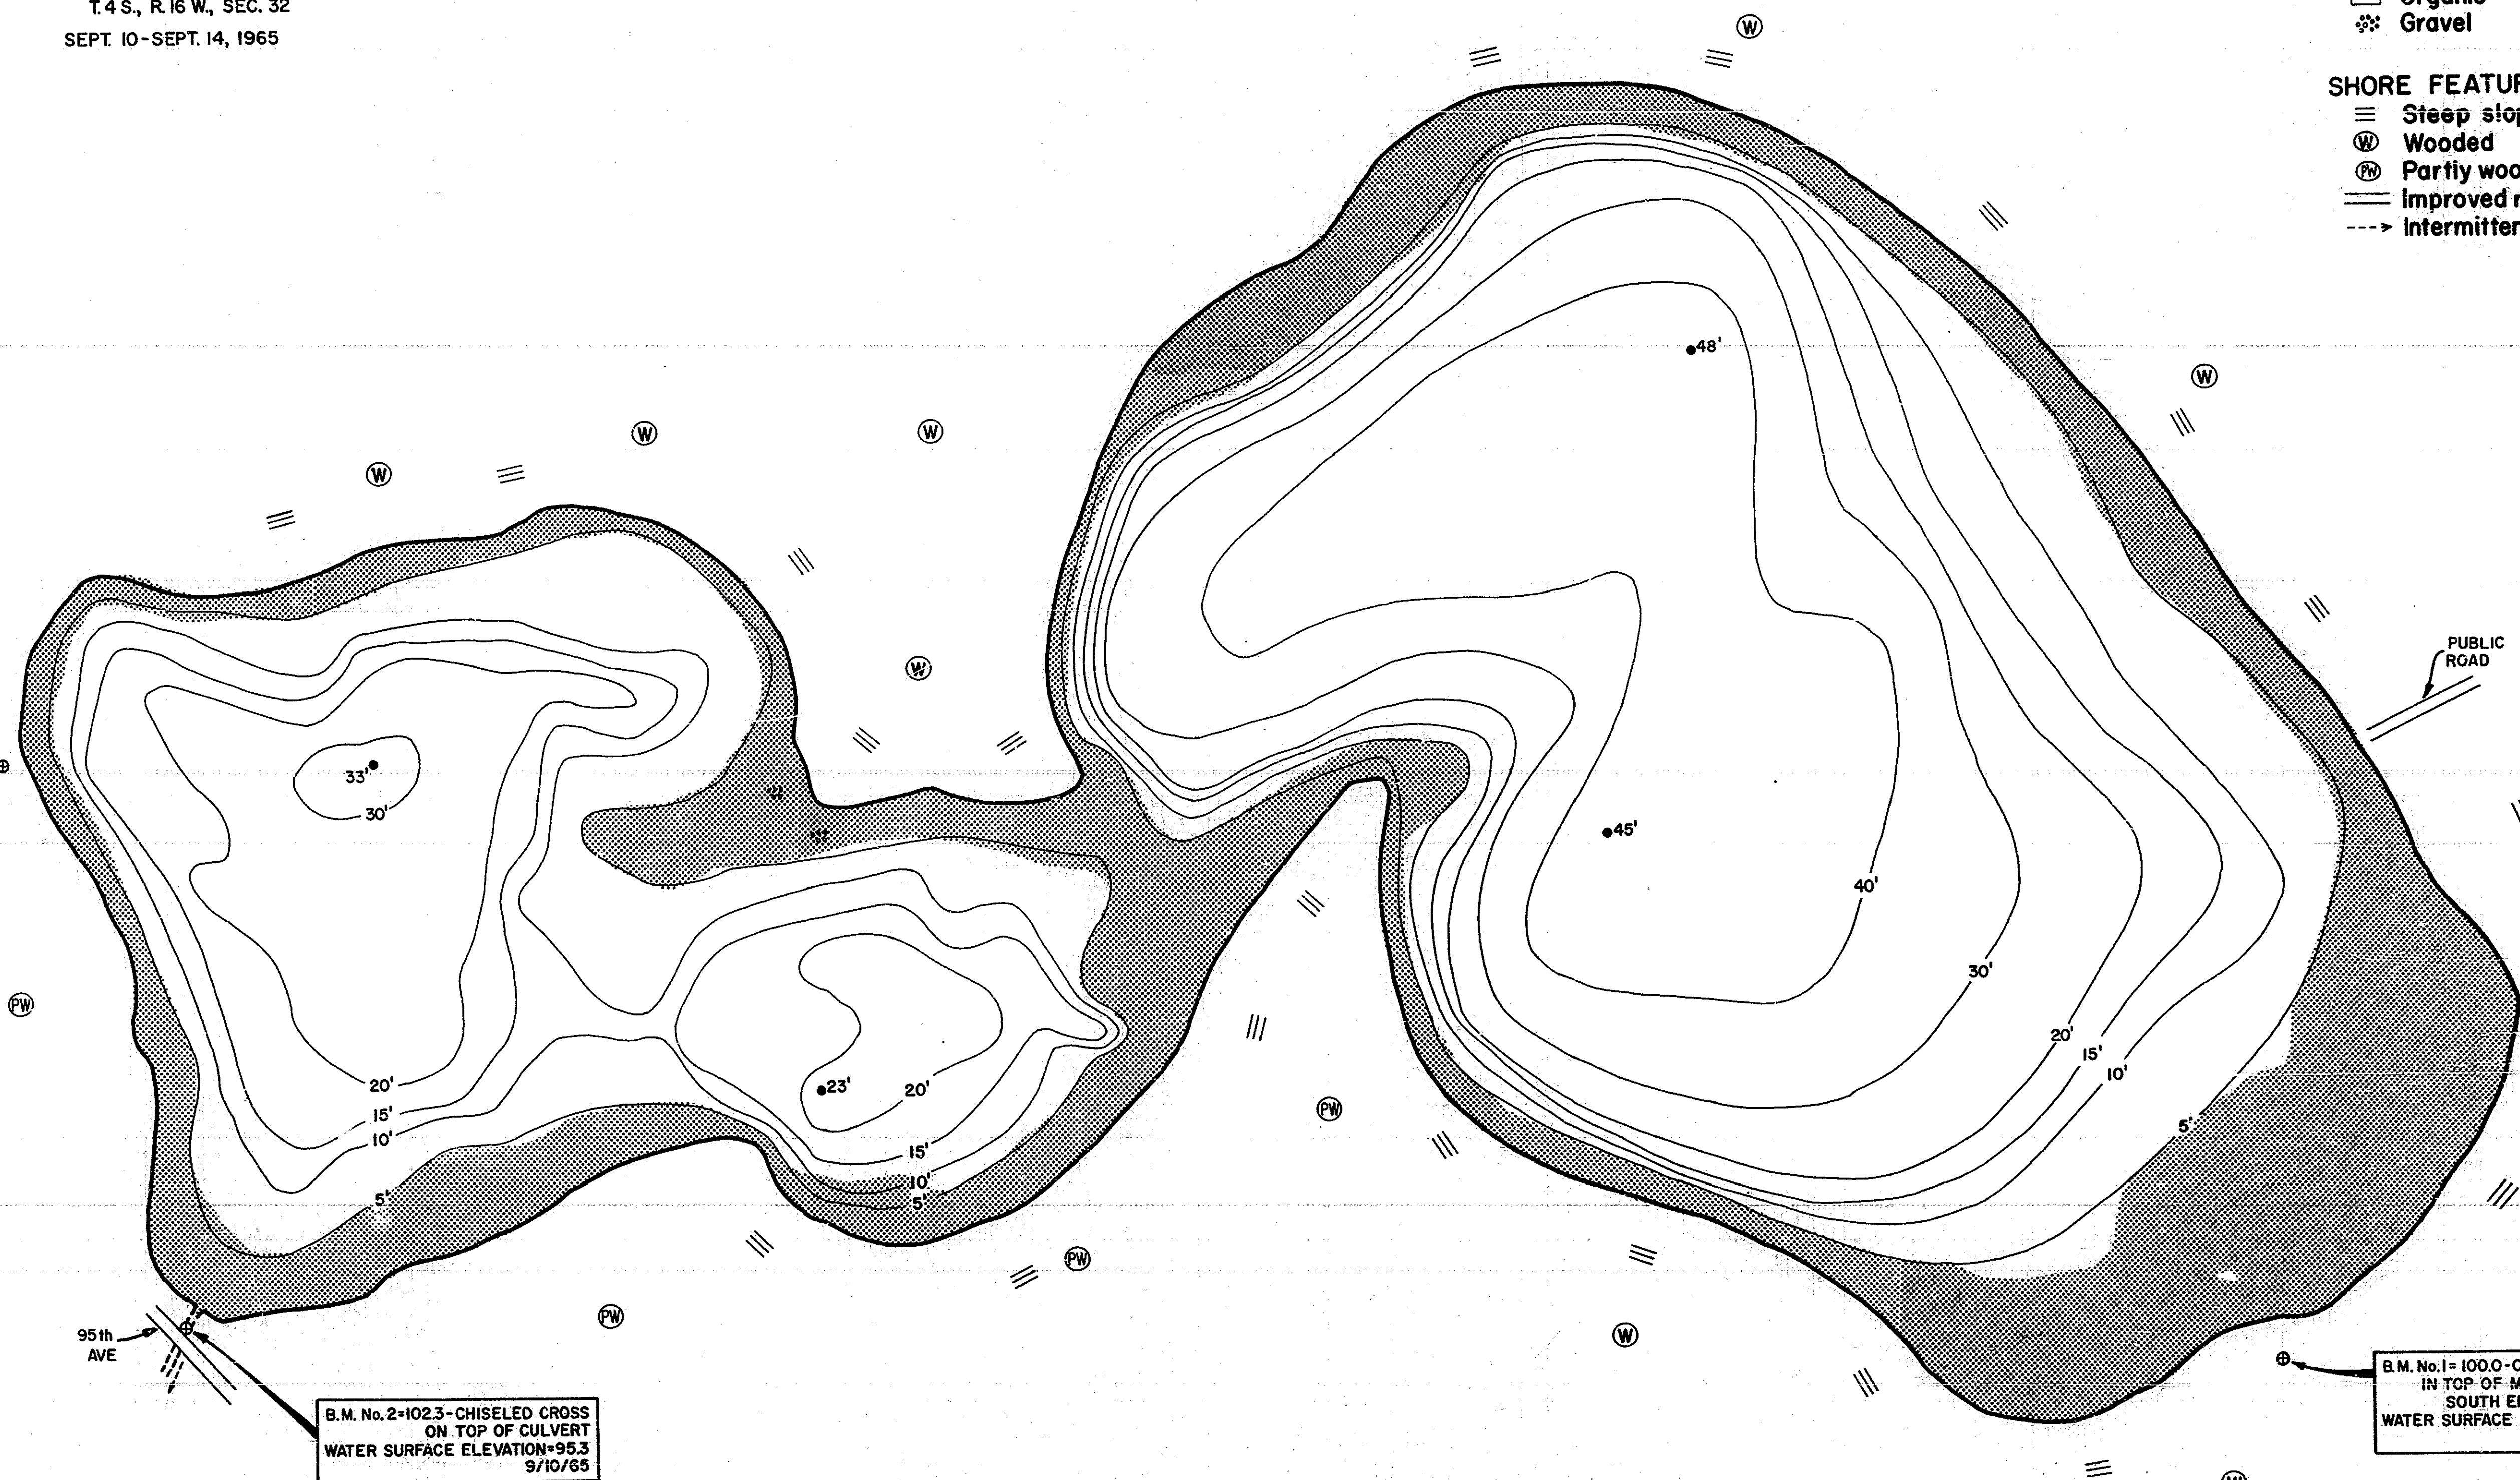
B.M. No. 3=97.4-CHISELED CROSS
 IN CEMENT AT BASE
 OF FENCE POST
 WATER SURFACE ELEVATION=95.3
 9/10/65

B.M. No. 2=102.3-CHISELED CROSS
 ON TOP OF CULVERT
 WATER SURFACE ELEVATION=95.3
 9/10/65

B.M. No. 1=100.0-CHISELED CROSS
 IN TOP OF MACHINE BOLT AT
 SOUTH END OF SEA WALL
 WATER SURFACE ELEVATION=95.3
 9/10/65
