Chippewa County Remonumentation Corner
LAND CORNER RECORDATION CERTIFICATE
Filing Requirement of Act 74, Mich. P.A. 1970

(I-13) Section Corner Common to Sections 34 & 35, T46N-R1E and Sections 2 & 3, T45N-R1E

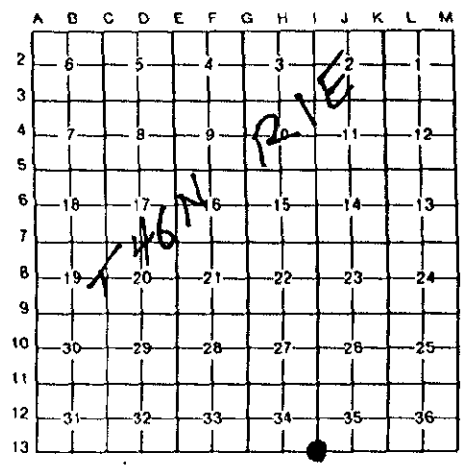
The Chippewa County Road Commission placed a monument box over pipe during reconstruction of Riverside Drive. Found mangled pipe in monument box and replaced it with a 3/4" x 24" iron pin. Corner position checks with three witnesses from 1982 record. Accepted position and established one new witness.

(I-13) Corner is a 3/4" iron pin in monument box in centerlines of Riverside Drive and Twelve Mile Road.

Witnesses: Northeast House Corner	N27°W	101.88'
Northeast House Corner	S61°W	58.98'
Utility Pole (DR1/76E/8)	N57°E	58.23'
12" Spruce	S38°E	150.39'
