Chippewa County Remonumentation Corner

LAND CORNER RECORDATION CERTIFICATE
Filing Requirement of Act 74, Mich. P.A. 1970

A. Description of original monument and accessories and/or subsequent restoration:
(I-10) 1/4 Corner Common to Sections 26 & 27, T45N-R1E

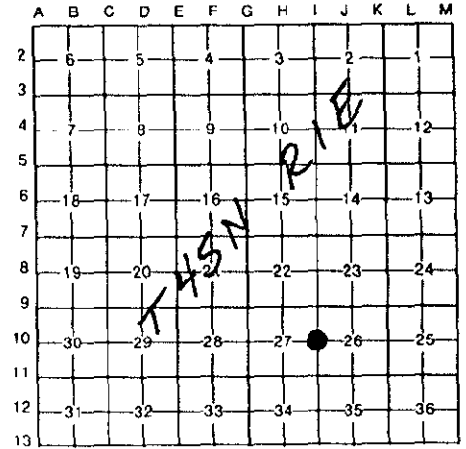
Found bent 1" pipe in centerline of Riverside Drive, on extension of drainage ditch to the West and extension of fence line to the East. Replaced bent pipe with 3/4" x 24" iron pin with plastic remonumentation cap. Corner position checks with four recovered witnesses from 1984 record.

(I-10) Corner is a 3/4" iron pin with plastic remonumentation cap in centerline of Riverside Drive.
